Bulletin

Governing Motor Sports in the UK

MSA SCRUTINEERS

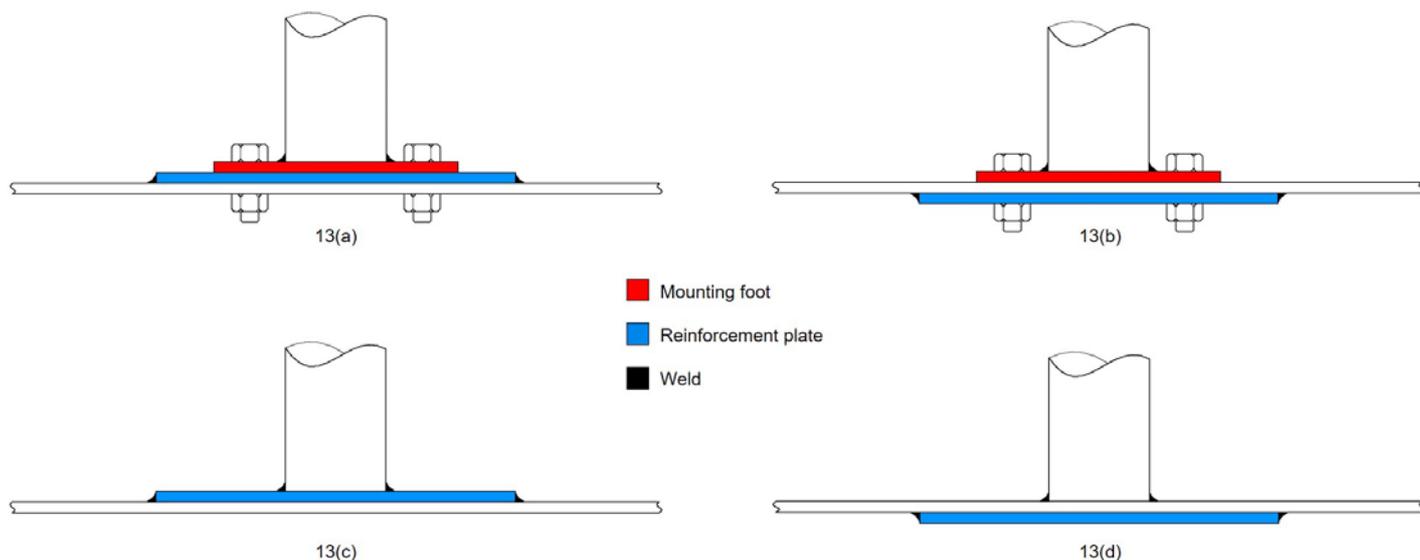
The amendment sets out to more clearly define how a ROPS should be mounted, initially dealing with a bolted fitment, with the inclusion of a mandatory reinforcement plate and mounting foot. It then goes on to confirm that the ROPS can alternatively be mounted by welding, with or without a mounting foot included. This last point is the key change, which now clearly defines that the ROPS tube may be welded directly to the reinforcement plate (or chassis if the reinforcement plate is on the underside).

There are new drawings under (K)13 (shown below) that have been included to add more clarity – and the regulations allow for a welded fitment in accordance with any of the four drawings (a)-(d). In the case of (a) and (b) the bolts need not be included if the fitment is fully welded (i.e. tube to foot and foot to reinforcement plate).

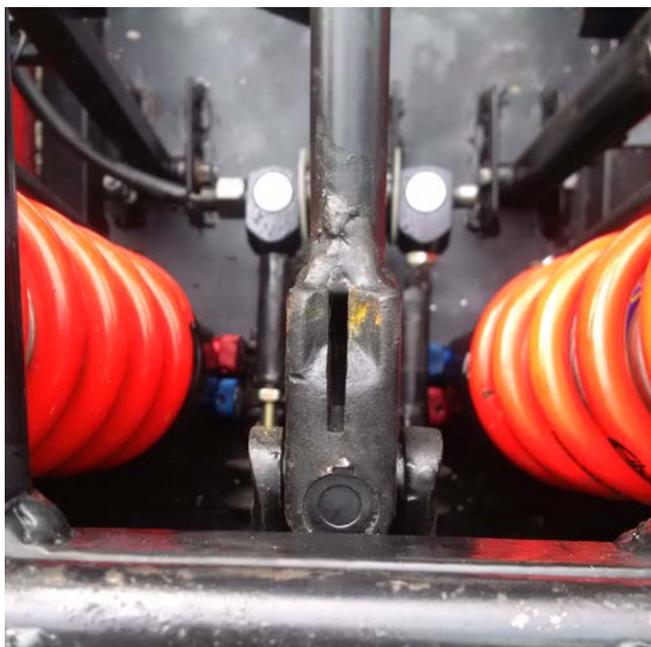
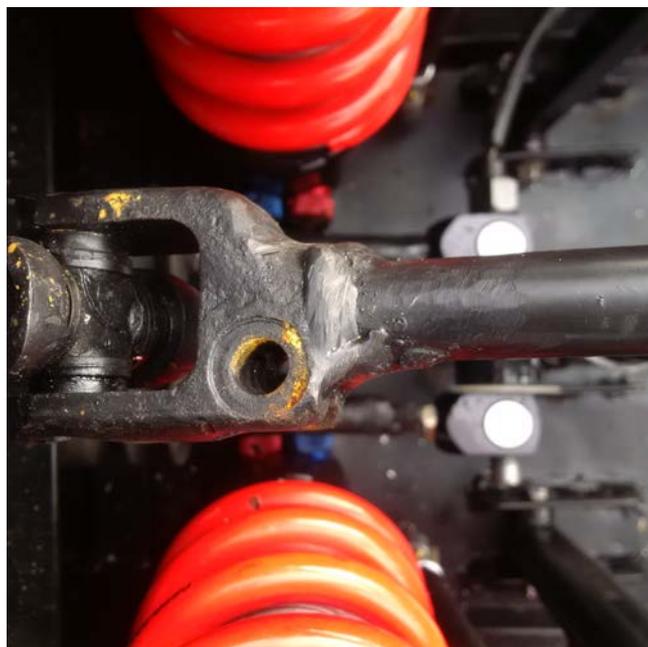
We are constantly impressed by what our Scrutineers pick up during routine Scrutineering inspections! This example of a steering rack/column from a single seater was recently presented for scrutineering, the Scrutineer spotted that the steering shaft does not actually enter the Universal Joint, the connection is totally reliant on a weld between the joint and the shaft. As the Scrutineer points out this is not a good idea where you have a steel shaft and cast Universal Joint.

This is another good example of the potential issues that can be seen by just taking a general look over the vehicle during your routine scrutineering, the competitor can then be advised accordingly to rectify such issues.

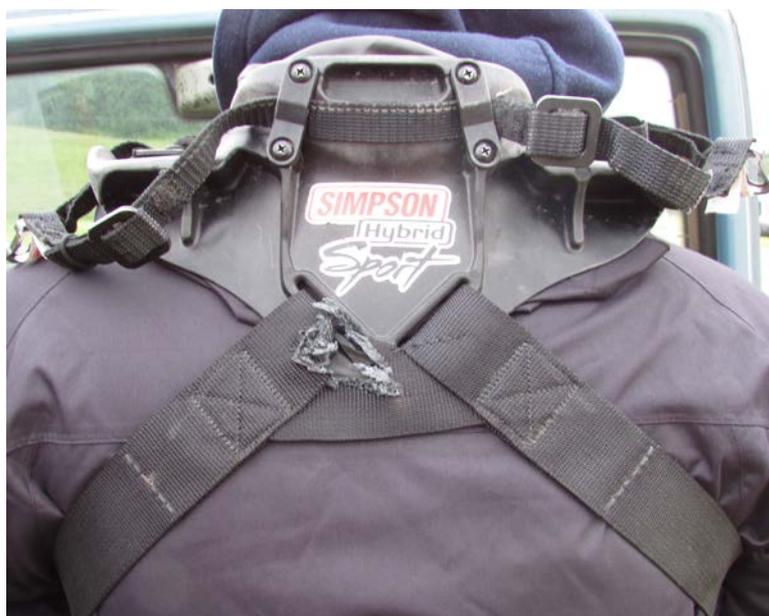
The photo here was forwarded to us recently by a Scrutineer who was presented with this very obviously damaged *Simpson* FHR at pre-event scrutineering for a Cross Country event – with the previously applied MSA FHR sticker already removed and the 'void' markings clearly showing! When questioned, the navigator explained that the damage was caused by a running drive-belt when he had crawled under the vehicle during a previous event, after stopping on course and attempting to attempt to fix a steering issue. So – as the scrutineer pointed out – not only protecting the neck, but the back as well!

Needless to say, in this condition – with such damage to the webbing straps – this FHR is not suitable for use, and in this case the Scrutineer correctly impounded the item for the duration of the event and the competitor sought out an alternative. It was then returned at the end of the event, with the instruction that it should not reappear at an MSA event!

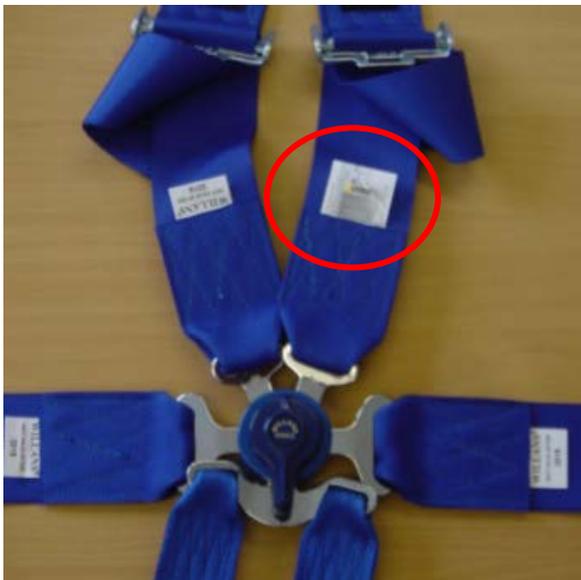
It may also be useful to note that some of the harness manufacturers write or print a reference number on the homologation labels that are sewn into each harness strap. If you find a harness where the reference number is not consistent across all straps you can be pretty sure the harness is not a complete set.

The example shown here (right) is how *Willans* marks its labels. You cannot rely

on all manufacturers doing this, but there is a reasonable chance that most will do something that makes it possible to identify a 'set'.

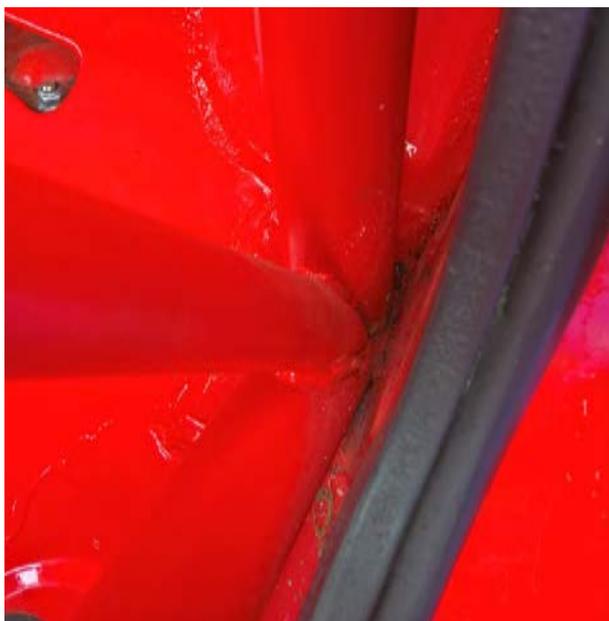
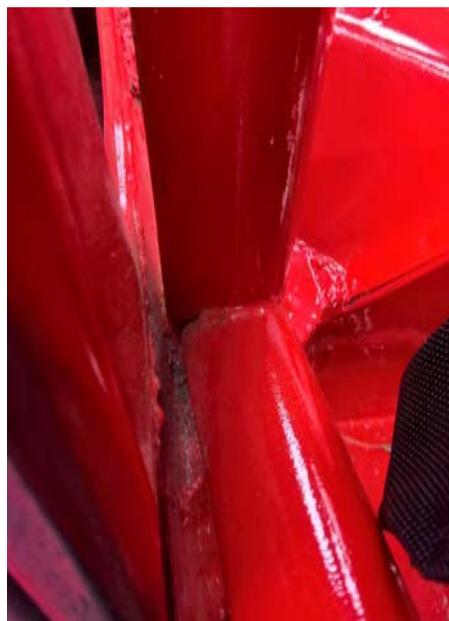
The photos below were forwarded to us by a Scrutineer who came across this ROPS installed in a car, with the claim that the car has been used for three years with no mention of any concerns. Looking at the photos, you can see that there are incomplete welds in both locations, presumably where these members have been added with the ROPS in situ, and no effort has been made to weld where access is restricted. Regardless of the restriction of access, for any mandatory ROPS member, Scrutineers should be looking for complete full circumference welds of adequate quality.

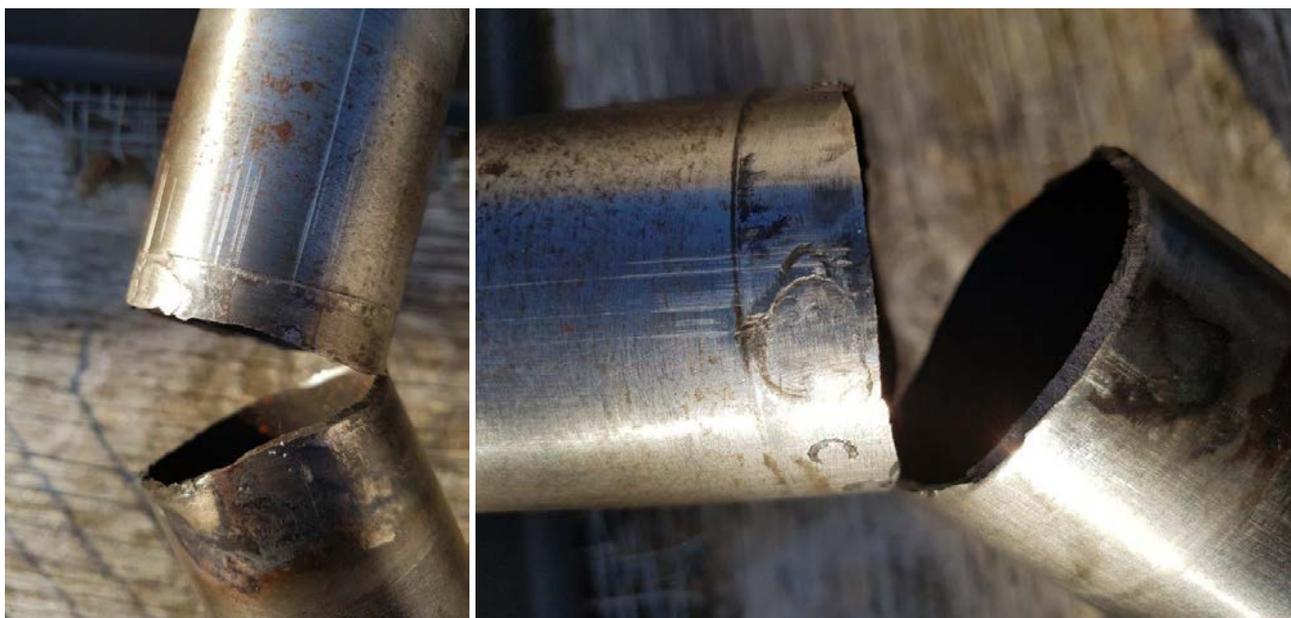
It has been a little while since we published an article concerning axle failures in Karting, but we do still receive reports from time-to-time of such occurrences. The photos here were forwarded to us following a recent Kart practice day, where this broken axle was handed over to the scrutineer. From the photos it appears to be typical of many other examples we have seen in the past, with the failure appearing to have manifested in the area where a number of grub screw indentations have been made around the axle. A reminder to competitors as they come through scrutineering of the importance of good axle maintenance and regular checks is worthwhile. If you do come across axle failures, please do continue to report them to the Technical Department, with photos such as these being a valuable addition to the report!
