Eligibility Training and Assessment

Steering wheel

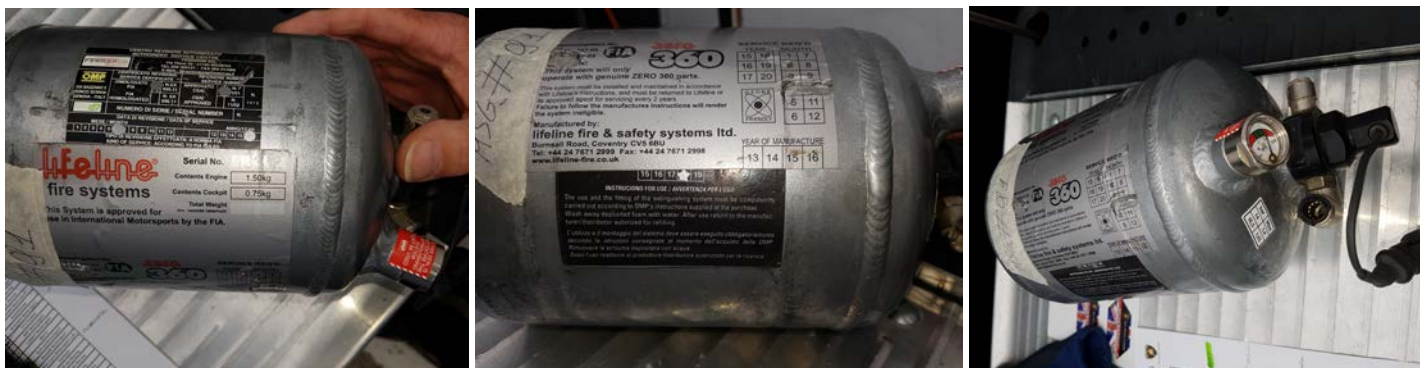
The images below were forwarded to us by a scrutineer, the issue was discovered on a car competing in a visiting International Series. The Scrutineers picked up that the extinguisher did not appear to be correct. After removal from the car for closer inspection the following was found!

An Initial view showed it to be a Lifeline extinguisher, but on closer inspection the lifeline label was stuck on top of an OMP label. The OMP label shows it to be in date (just), whereas the lifeline label was not distinctly marked but appeared to show a February 2018 service date. The lifeline label was shown not to be for this extinguisher bottle as it detailed the extinguishant as Zero 360 gas, whereas the bottle contained AFFF foam!

The International series mandates the use of the OMP AFFF system, and when compared to a new "correct" bottle this extinguisher was found to be 0.5kg lighter, despite the gauge showing correct pressure. This is another example of the scrutineers being vigilant, and developing a "nose" for what is correct or not.
